CCR SURFACE IMPOUNDMENT EMERGENCY ACTION PLAN

Plant Gaston Gypsum Pond

ISSUE DATE: April 15, 2022
REVISION #: 1

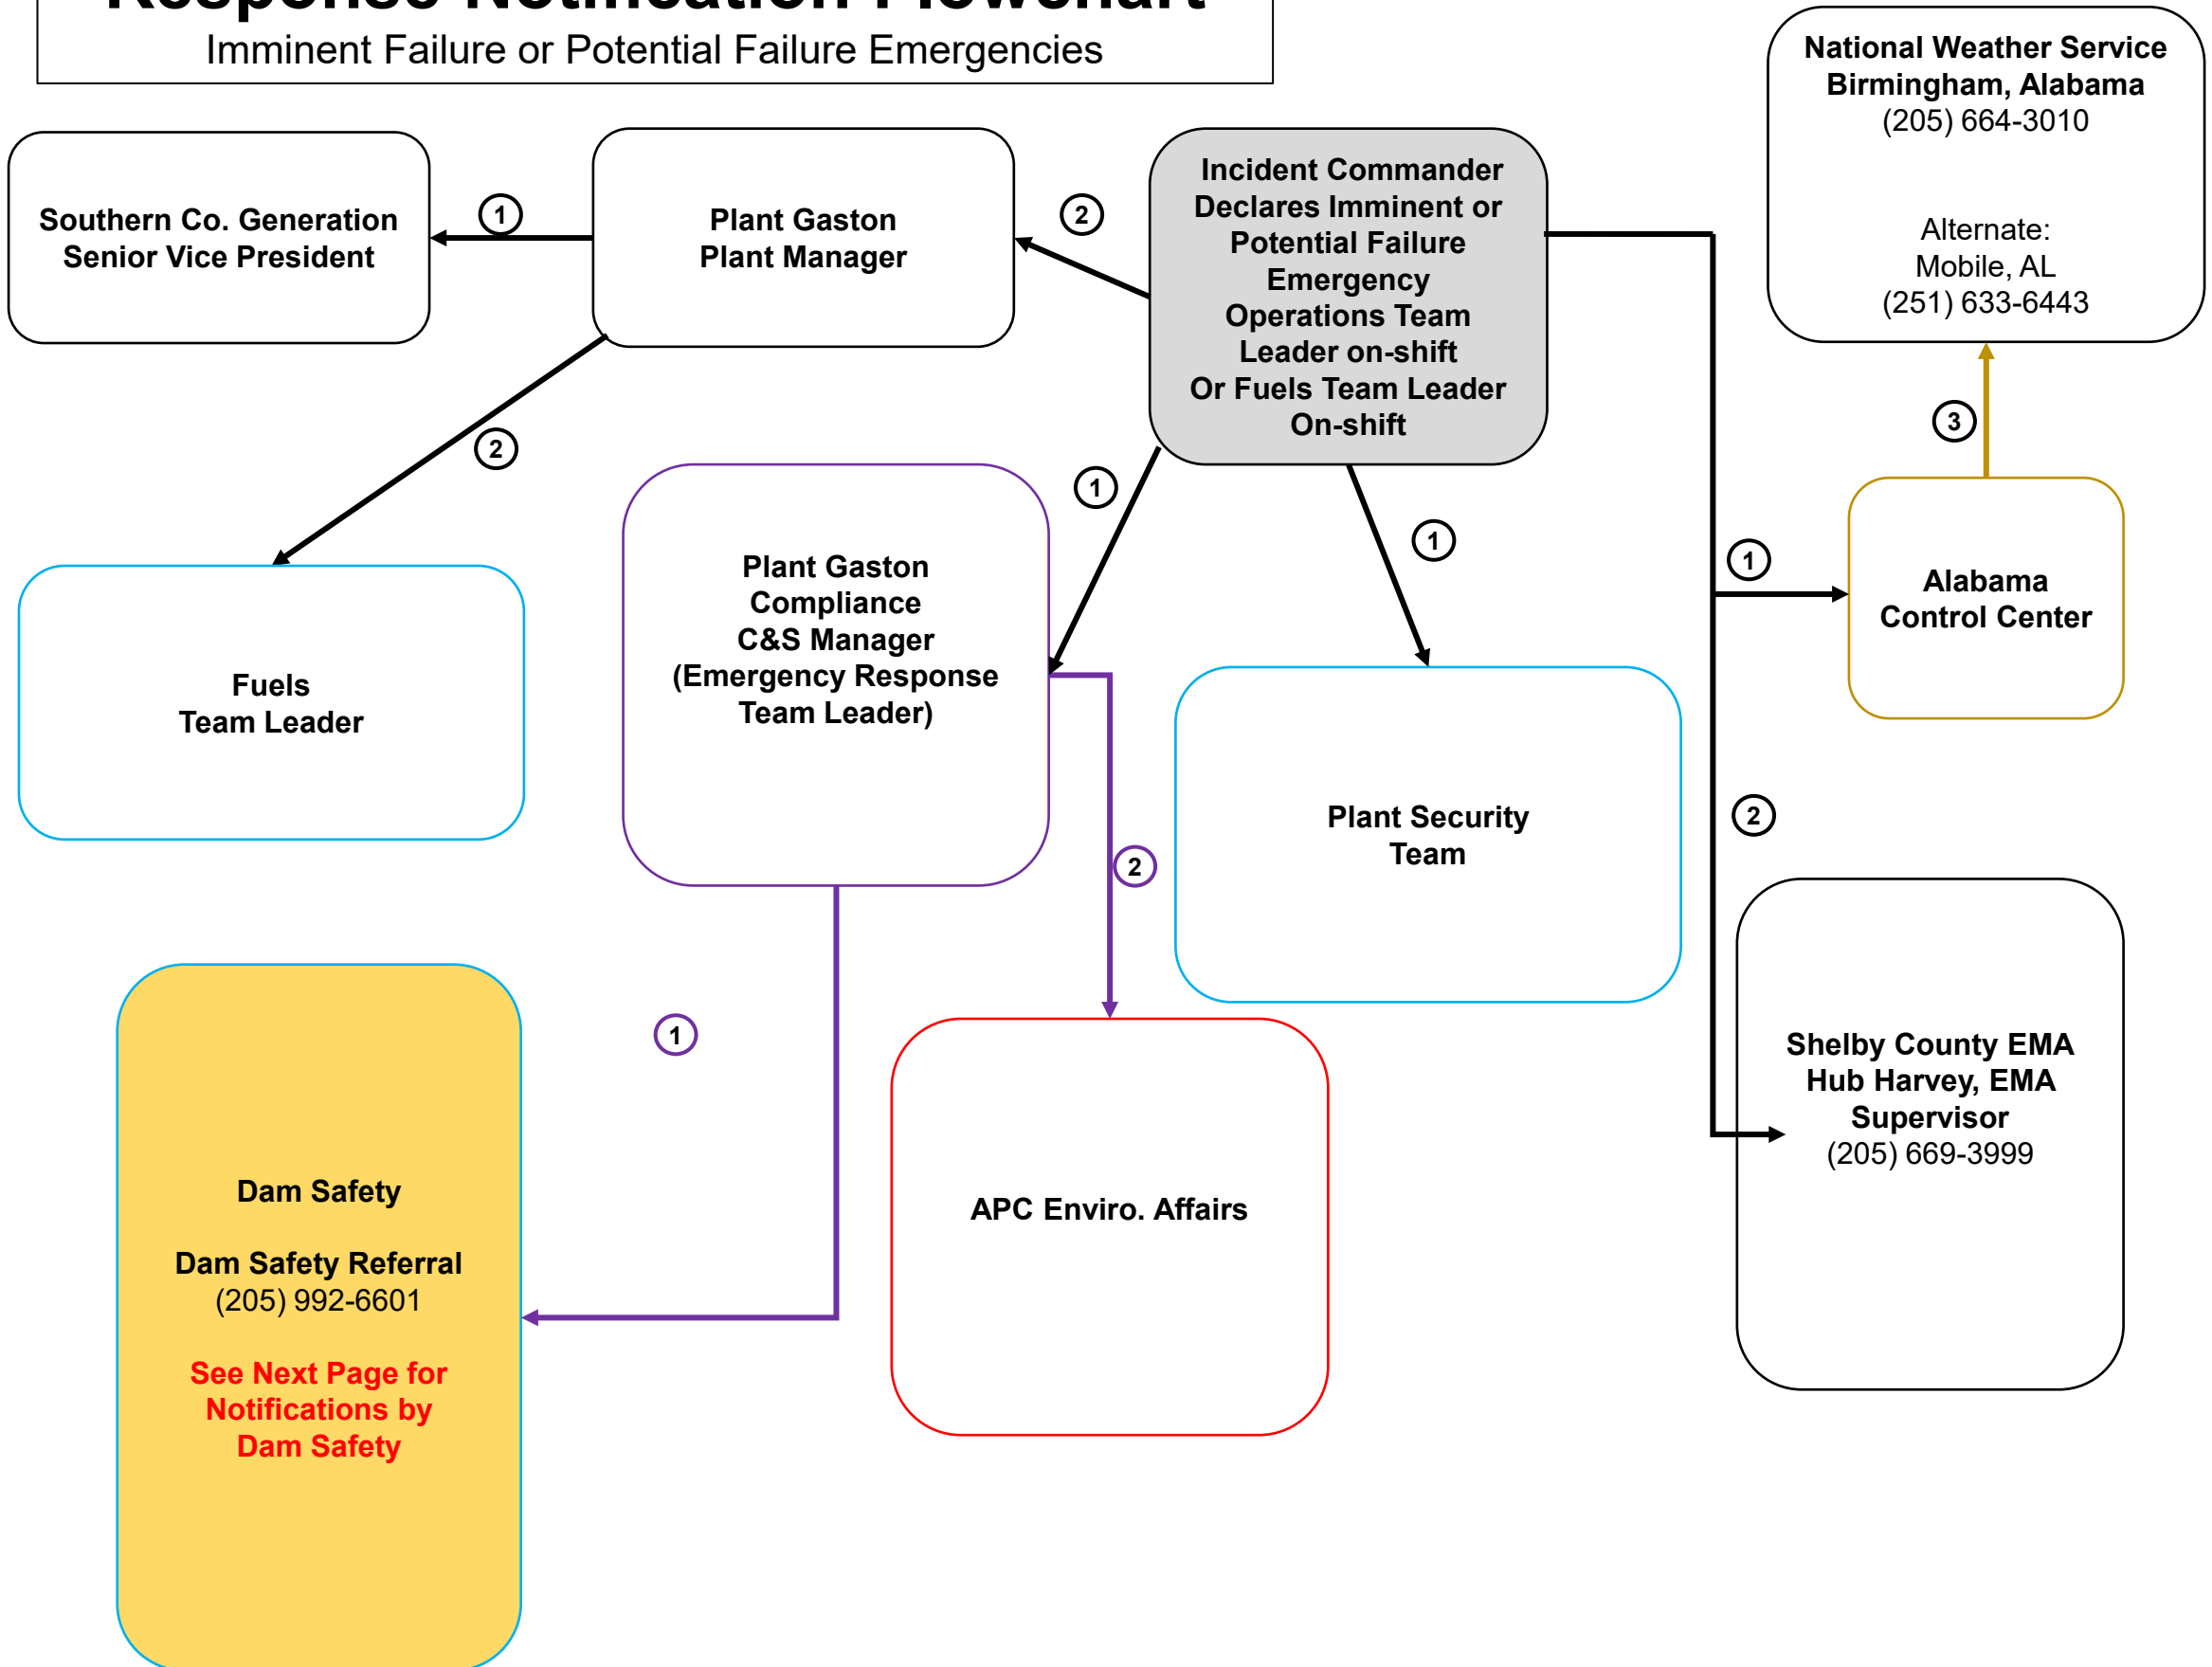
Response Notification Flowchart

Imminent Failure or Potential Failure Emergencies
